Ruptured Gas Cylinder Destroys Laboratory Hood at the University of Nevada

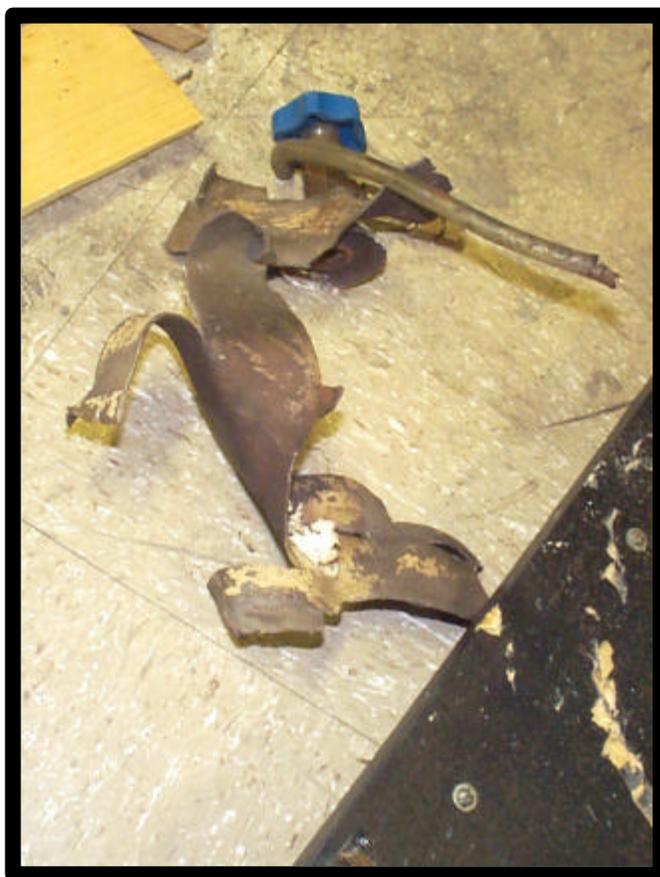
Ruptured Gas Cylinder

The gas cylinder containing the methyl nitrite ruptured violently, blowing the top cylinder cap off at the weld seam, and twisting the body of the steel cylinder. The cylinder was blown through the front sill of the lab hood, while the blast from the explosion shattered the hood sash, blew off the cabinet doors located underneath the hood, and destroyed the back and top of the hood. The force of the explosion even bent a metal support bracket used to secure utility lines located above the hood. Additionally, the blast produced a crack in an adjacent wall, just outside of the hood opening.

Although steps were taken to evacuate the used gas cylinder, and high heat or pressure was not present, apparently the cylinder contained residues and reactive surfaces that initiated the chemical reaction that led to the explosion. *Never refill gas cylinders with highly reactive or corrosive compounds, including the original compound contained in the cylinder.*

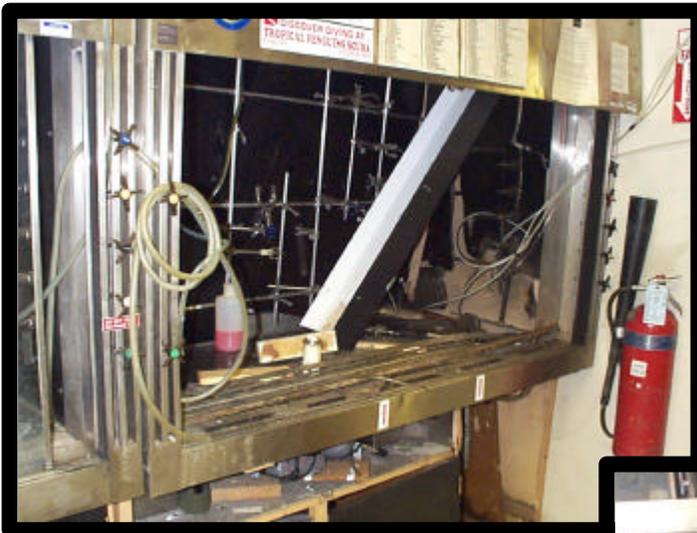
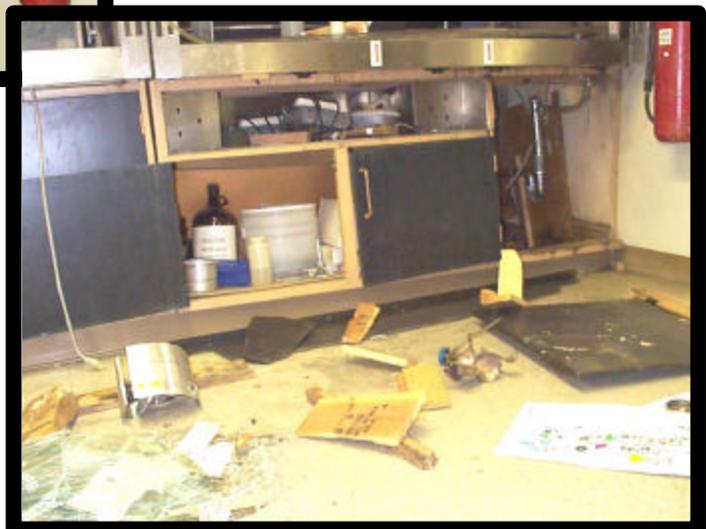
There were very few chemicals located either in the hood or in the cabinet underneath the hood, a fact that surely prevented a fire or significant chemical spill. Although it appears that there was a flash fire associated with the explosion, a sustained fire was probably prevented by the use of a flammable storage cabinet located away from the hood. The only chemical spill was an unknown quantity of ammonium hydroxide from a container that was broken by the blast. There was no free liquid remaining, indicating that the ammonium hydroxide volatilized and was captured by the hood, or surrounding cabinet materials absorbed the liquid. See [additional photos](#) of damage to the lab hood.

Damage to the lab hood and cabinet

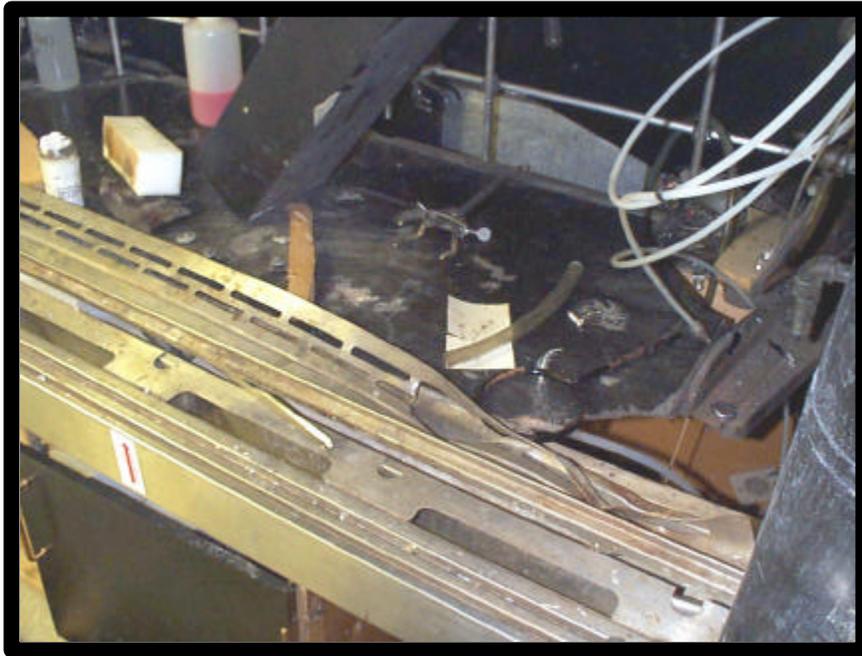
Gas cylinder was propelled through hood airfoil

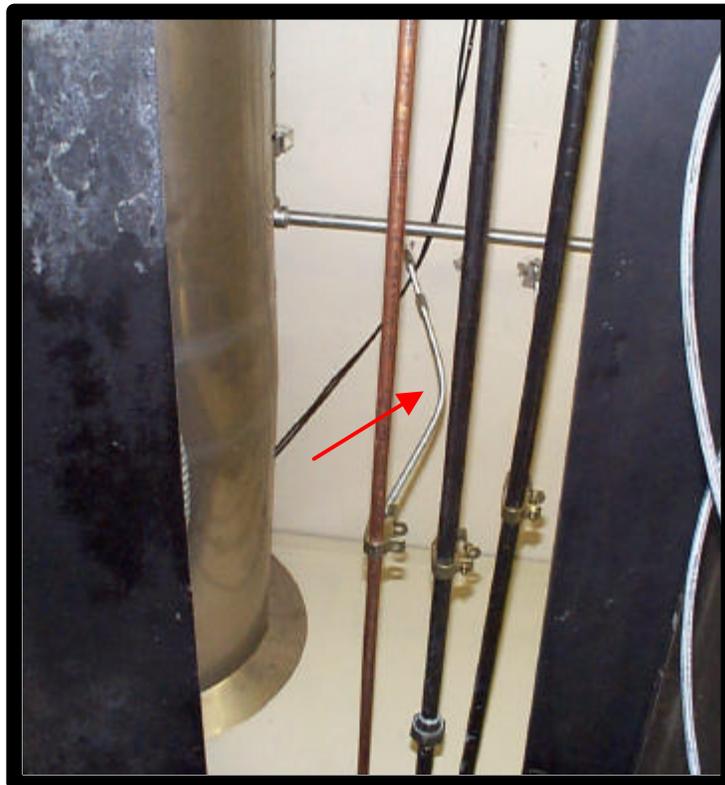
Damaged utility line support above hood (see arrow)

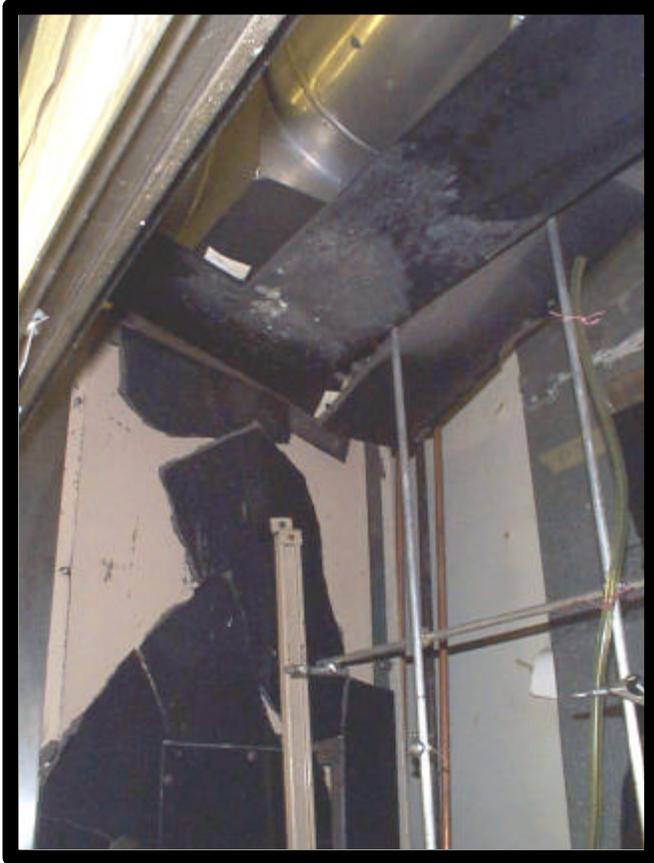
Damage to top and rear of hood

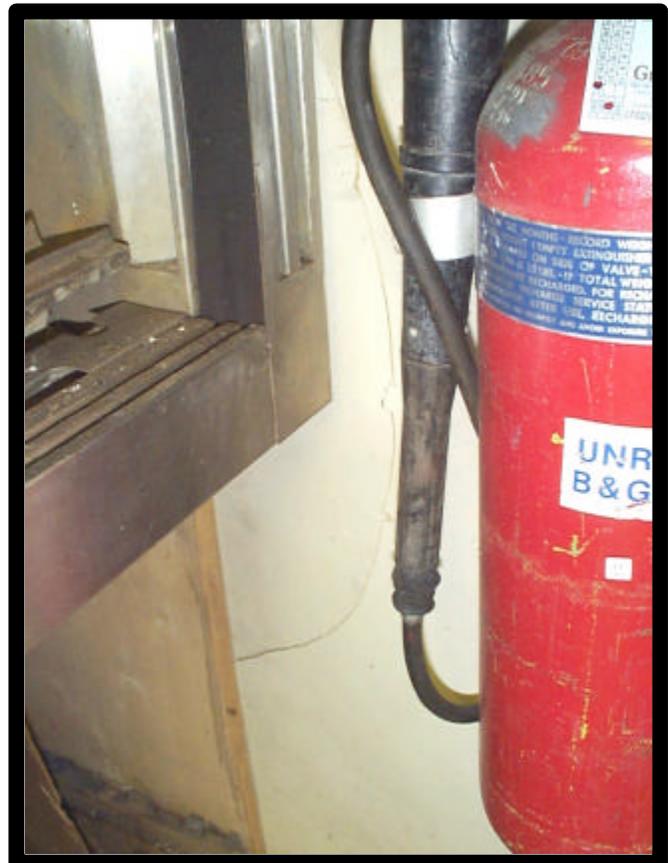
Damage to wall (crack) adjacent to hood
