What Happened?

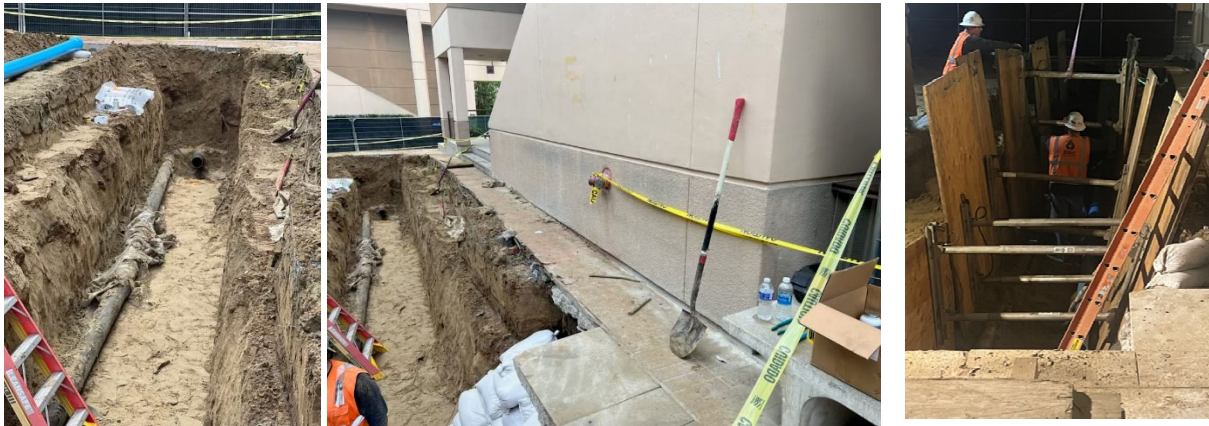
On October 23, 2023, the campus contracted a third-party contractor to repair a ruptured 6" fire/domestic water line near the Physical Sciences Lecture Hall. The contractor excavated a 22'(l) x 5'(w) x 6'(h) trench adjacent to the building to make the repairs. The default soil classification on campus is "Type C." When excavating a trench in Type C soil five feet or deeper, [Cal/OSHA](#) requires either sloping (when there is room) or shoring to protect workers from potential cave-ins. EHS staff inspected the construction site and observed contractor employees working inside a partially benched trench without appropriate shoring equipment installed. EHS notified the assigned project manager and instructed the contractor to stop operations and vacate the trench until the required/appropriate documentation was generated and the shoring equipment could be installed.

After the trenching operation was stopped and the contractor staff vacated the trench, a review of the required trenching and shoring records was requested to ensure the contractor adhered to UCI trenching and shoring requirements. The contractor could not provide a copy of their annual CALOSHA trenching permit or other necessary documents required for excavation work on campus (e.g., trenching and shoring plan/Standard Operating Procedures (SOPs), competent person daily trench inspection log, etc.). In addition, a sign was not posted at the construction site entrance warning pedestrians of the potential dangers inside.

The direct cause of this incident is that the contractor allowed their employees to work inside a trench that was not properly protected from potential cave-ins and did not adhere to applicable UCI trenching and shoring requirements.

The incident's root cause was that the project manager relied on the contractor to ensure that the proper protective systems were in place, did not review/require the contractor to provide required documentation, did not notify EHS of the dig and receive proper authorization before the contractor employees were allowed to access the trench. As a result, Campus employees did not recognize that the trench entry was unsafe.

- All trenching and shoring operations must follow applicable UCI Trenching and Shoring requirements.
- Contractor employees should not be allowed to work inside of an excavation 5' or deeper without a verified trench permit from [Cal/OSHA](#) .

- All required documentation should be submitted and reviewed by a UCI "Competent" person with oversight responsibility for the project.
- EHS should be notified prior to authorizing access to an excavation 5' or deeper.

- Contractors performing excavations should conduct the required soil classification review and be informed that the default soil classification on campus is Type C unless their competent person deems otherwise. Benching is not permitted as a protective measure in Type C soil.

- Regardless of soil classification, contractor employees should not be allowed to work inside an excavation that is 5' or deeper unless all applicable Cal/OSHA guidelines are followed to prevent potential trench cave-ins.
